# Hurt House at Stead Park

Phase I/II Archaeological Investigation

District of Columbia Site 51NW223

DRAFT – October 2008

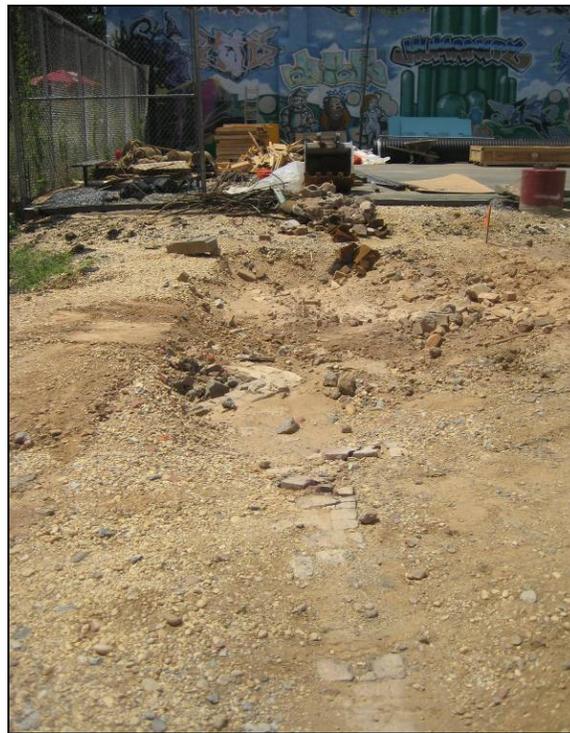
**Figure 1: Potential Archaeological Resources**

In the spring of 2008, the District of Columbia Department of Parks and Recreation (DPR) began renovations of Stead Park located at 1625 P Street, NW in Washington D.C. The purpose behind the renovations was to increase recreational opportunities and improve the park's physical and visual appearance, and thereby enhance the overall usability of the site by the surrounding community. To meet this need, DPR developed a plan that called for the demolition and rebuilding of certain areas of the park. Work commenced on Stead Park in the spring of 2008. While the construction crew was grading the site in preparation for the improvements, they uncovered what appeared to be foundations (Figure 1).

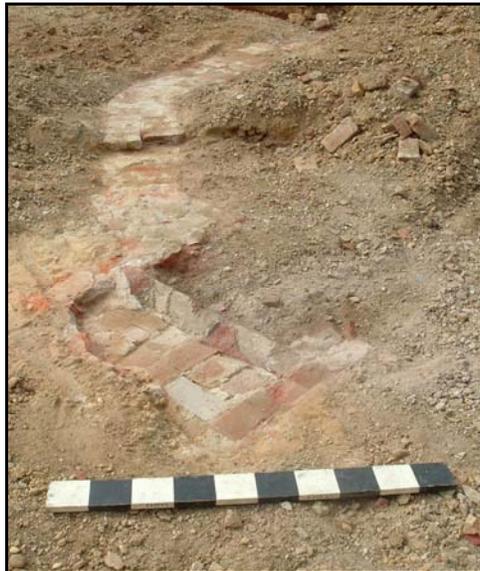
**Figure 5: Bay feature**

Field investigations unearthed the outline of three of four sides of the rectangular brick structure; only the north wall could not be located. The north wall was the location of several additions, including a storeroom and an elevator shaft, the latter of which was located. Another addition along the east wall, the bay (Figure 5), was also located. The field investigations indicate that the basement of the structure was filled with brick and other structural debris at the time of demolition. The area outside of the structure was dense clay subsoil that lacked artifacts. As well, no builder's trench was identified in the machine trenches excavated across the foundation and foundation wall. Perhaps most interesting was the presence of an asphalt floor that appeared to have been laid over a brick floor. The asphalt floor, including a series of grooves, appears to have been part of a sleeper system (Figure 6). Given the super-positioning of the asphalt floor over a brick floor, it is likely that this sleeper system was installed during either the late 1880s or mid-1890s remodeling of the Hurt House.

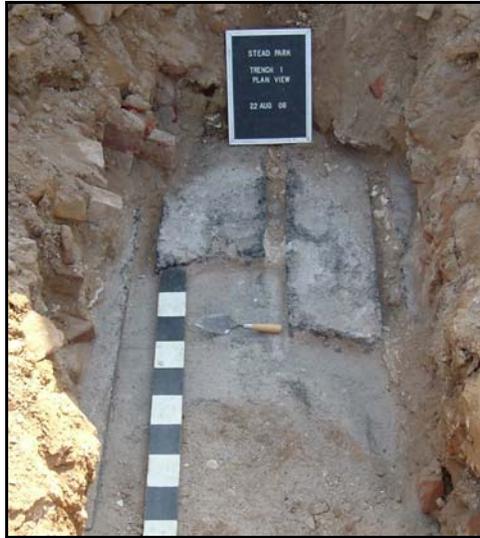
**Figure 6: The grooved asphalt surface.**

The artifacts recovered during the field investigations were overwhelmingly architectural in nature. These were mainly ceramic and slate tile, window glass, and nails. Bricks, while numerous, were generally not collected. Few domestic items, either kitchen-, personal-, or activities-related, were recovered. The artifacts appear to have a manufacture and use range between the 1860s and 1930s, which equates quite well with the period of occupation, from the 1870s through the 1940s, derived from documentary research. The paucity of domestic artifacts also largely precludes an investigation into the daily lives of the Hurt family or their approach to the consumption and display of their wealth. Lastly, the nature of artifact deposition at the site does not allow for the separation of artifacts between the period of occupation of the row house by Henry Hurt and his family and that of the occupation by his niece Fannie Gue and her family.

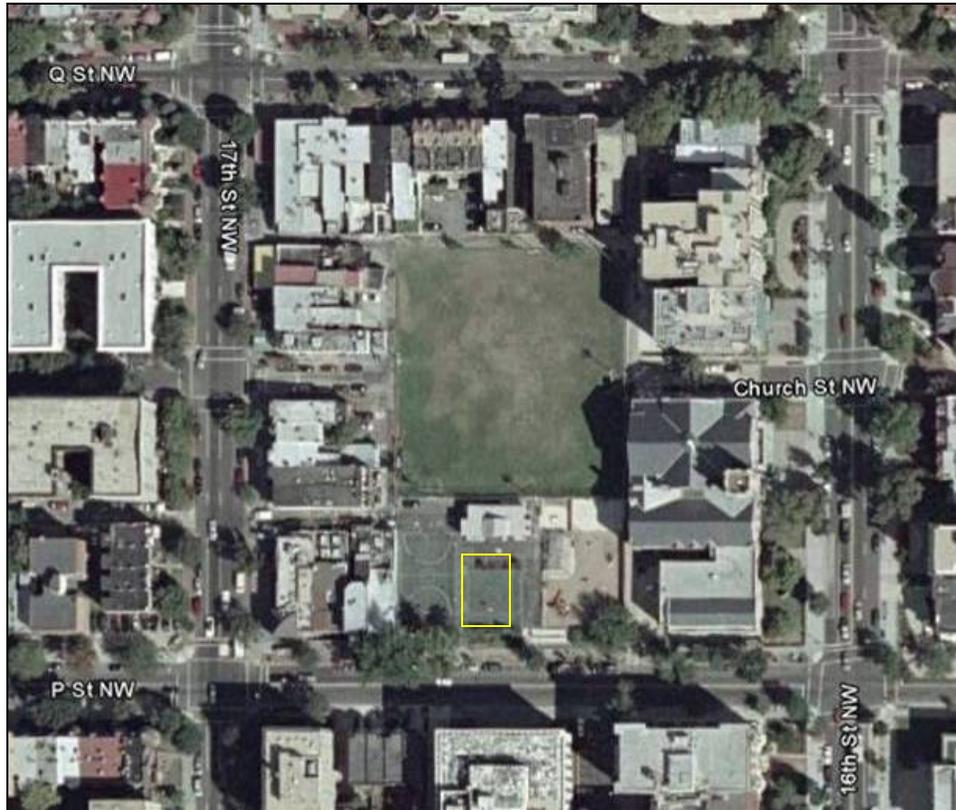
Figure 2.2: The Phase I/II Archaeological Area of Interest (Google Earth, 2008)

The Phase I/II archaeological area of interest is limited to the southern portion of the Stead Park. The area of potential impact excludes the one acre athletic field to the north. The southern portion of the site encompasses a former carriage house now used as a recreation center building (Figure 2.2) and until recently contained a playground, plaza and basketball courts. Stead Park is currently undergoing substantial renovations to enhance the overall usability of the site by the community. In April 2008, the playground and plaza were demolished to accommodate updated recreational amenities. During the course of demolition, the DPR uncovered potential archaeological resources, consisting of the remains of a brick foundation wall, on the site. The area of interest, based on the location of these remains and a 1945 structure plat, was defined by DPR as a rectangle, 75 by 40 feet, extending from P Street, NW north to the carriage house and bounded to the west by a basketball court (Figure 2.3).

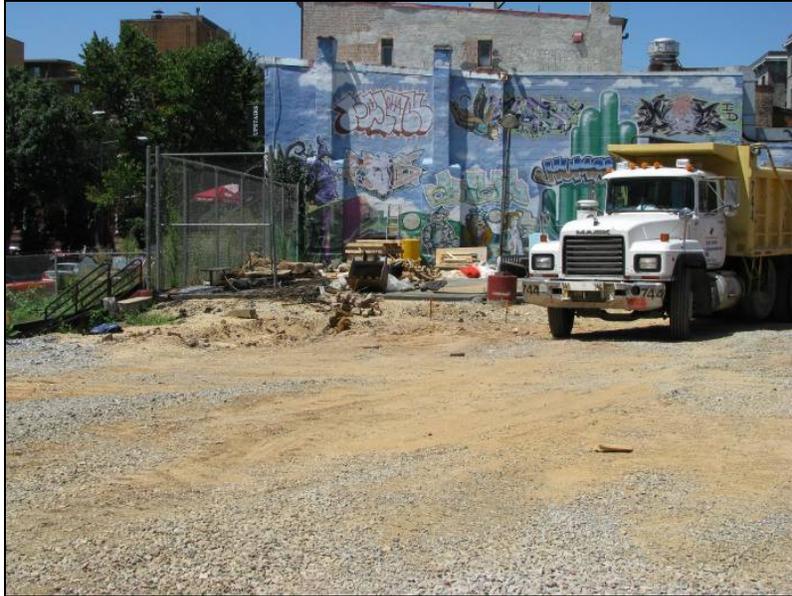
**Figure 2.4: Stead Park under Construction (facing west)**

As of August 2008, DPR had completed the demolition work and the eastern portion of the site had been graded in preparation for the construction of the new playground and plaza (Figure 2.4). The potential archeological resources were demarcated on the site pending the findings and recommendations of this Phase I/II archaeological investigation (Figure 2.5).

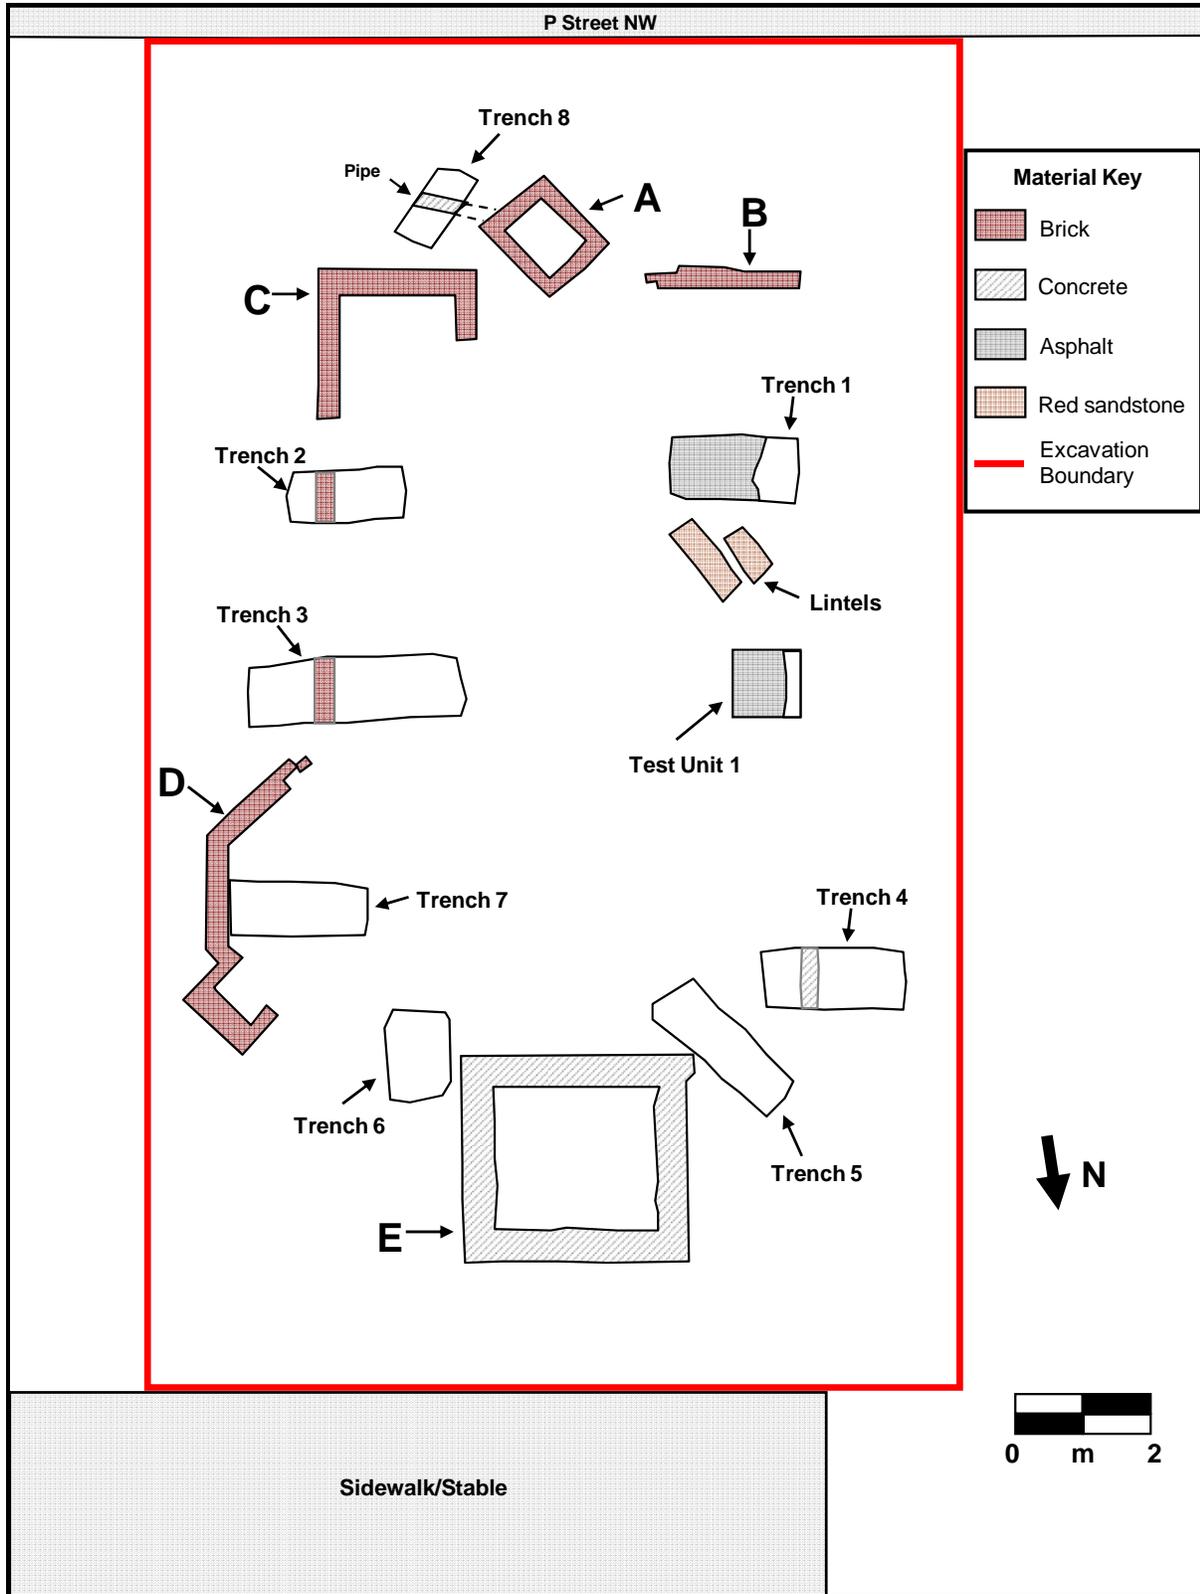
Figure 6.1: Results of Excavations at Stead Park

The first field investigation task was to remove the upper deposits within the remainder of the area of interest that had not been previously removed by the DC HPO trench. This was done in an attempt to follow the outline of additional foundation walls and to identify additional features. It was decided that the upper surface deposits would be removed to a depth that was approximately the same as that of the DC HPO trench, to approximately 20 cm below ground surface. A backhoe with a toothed bucket was used to remove the upper deposits (Figure 6.3). A machine with a toothed bucket was necessary due to the amount of structural debris present within the area of interest, as well as the heavy, compacted gravelly clays that comprised the soils surrounding and to a lesser extent within, the structure footprint. The backhoe began to remove the upper deposits along the north boundary of the area of interest, generally exposing areas in a north to south direction. When the upper deposits in an area had been removed, the field crew then began to clean loose debris from the area in an attempt to locate features (Figure 6.4). The results of field investigations are described in this section by general location within the DPR-defined area of interest.

Machine Trench 2 was excavated approximately 2.5 feet north of the southeast corner wall (Figure 6.1). This trench was started to the east of the southeast corner wall and continued approximately 5.5 feet to the west. The trench is 2.25 feet wide. At 1.25 feet to the west of the east trench wall the brick masonry foundation wall was again encountered (Figure 6.8). Visually, this segment of the wall was in line with that exposed on the surface to the south and that in Machine Trench 3 to the north, but once again it is situated to the west of the bay. Prior to trenching, it appears that one course of brick remained over the concrete foundation. The foundation wall in Machine Trench 2 was encountered at 40 cm to 50 cm below the previously excavated ground surface. Deposits to the interior of the foundation wall consisted of structural debris.

The final attempt to locate the west wall was Machine Trench 4 (Figure 6.1). Machine Trench 4 was excavated to the west of Machine Trench 1 and Test Unit 1, and was placed 12 feet to the north of Test Unit 1, near Machine Trench 5 and the elevator shaft feature. Machine Trench 4 was oriented east-west and measured 7 feet by 2.75 feet. The trench was initially excavated to a level of 40 cm below ground surface but no indications of a wall foundation were located. Subsequently, a small unit was hand-excavated approximately 1.5 feet west of the east wall of this machine trench. Visually, this area was thought to be the location where the wall foundation would have been placed, based on a correlation between the 1945 structure plat and the location of the standing carriage house. A 35 cm long unit was excavated across the width of the trench, and at 34 cm below the machine trench base, or 75 cm below the scraped surface, a poured concrete feature was found (Figure 6.15). The concrete appears to be similar to that noted at places along the east wall, and is in the correct position predicted for the west wall based on the 1945 structure plat. This concrete feature is most likely the wall foundation. The inability to locate a brick masonry foundation wall above the concrete foundation along the structure's west wall may indicate that demolition of the structure removed the foundation wall from this portion of the row house. It also likely accounts for much of the brick rubble found in the interior of the structure.

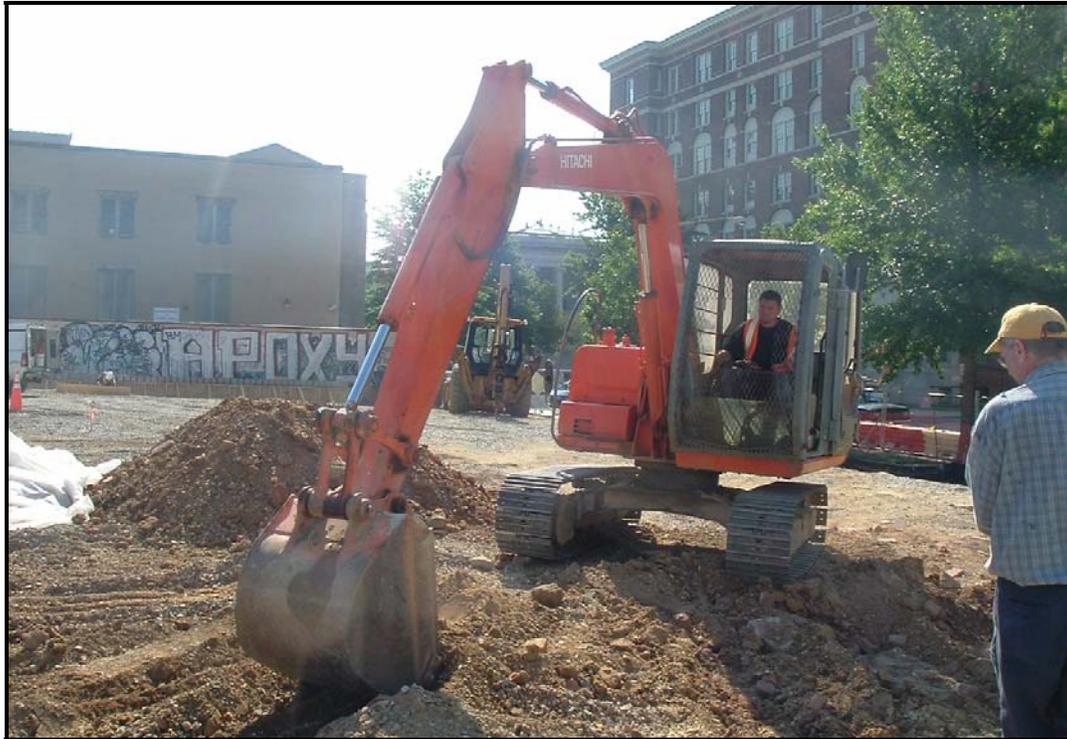
**Figure 6.3: Monitoring while backhoe removes the surface deposits.**

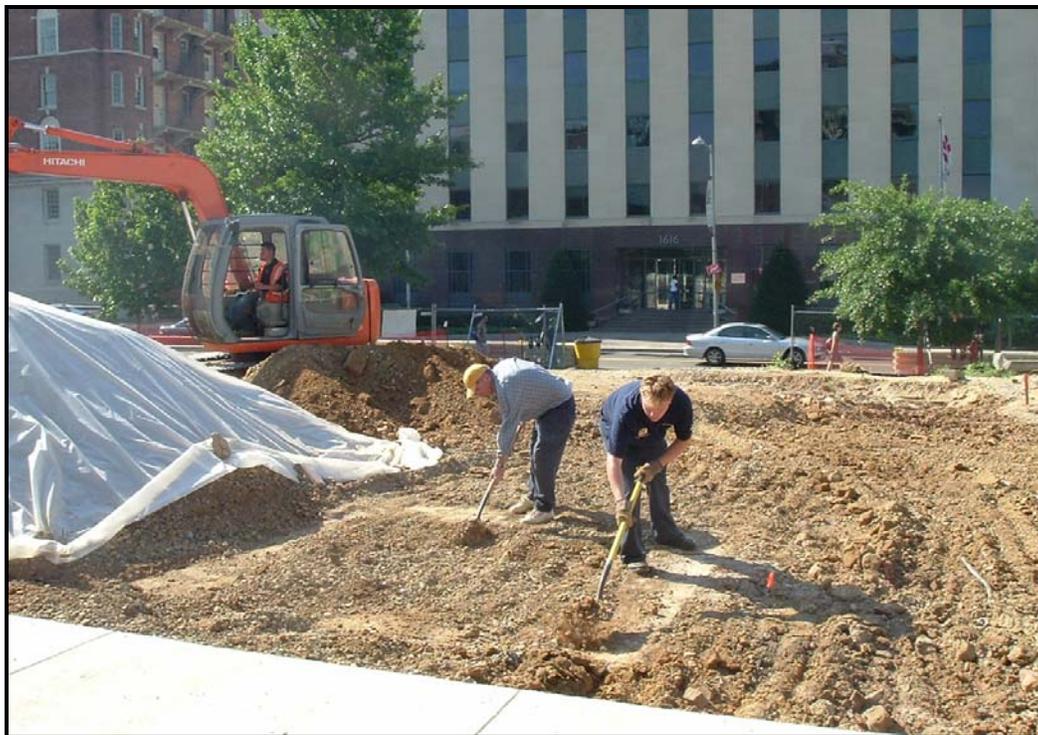
**Figure 6.4 Crew cleaning recently excavated area**

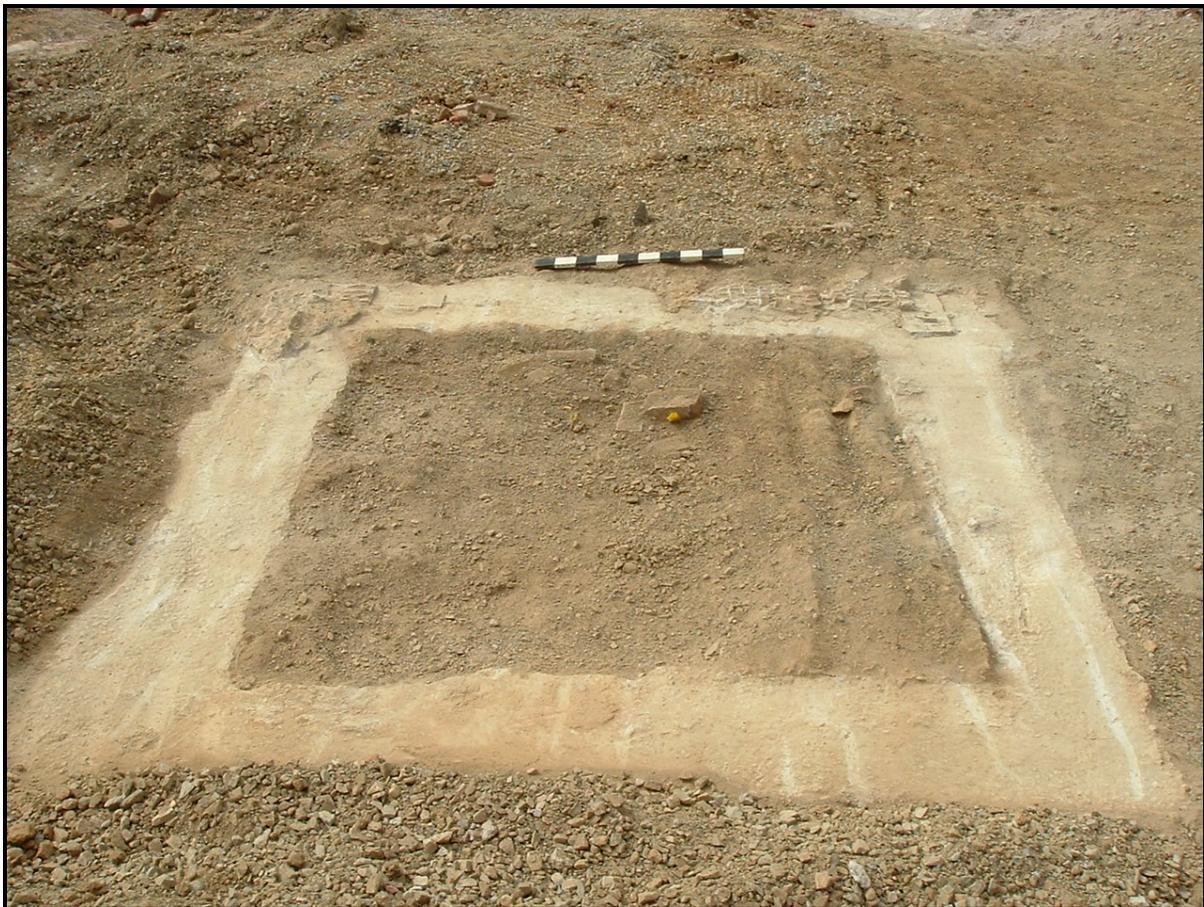
Figure 6.5: Elevator shaft feature

Archival and historic map research, presented in Section 4, led to a set of expectations for the area in the northern one-third of the area of interest. It was anticipated that excavations could possibly uncover the original north wall of the 1870s structure, extensions, including a store-room, that were added after 1888, and an elevator shaft, which was added in 1921. The first feature uncovered was located along the northern boundary of the area of interest. This feature was set less than 6 feet south of the carriage house sidewalk and approximately midway between the eastern and western boundaries of the area of interest. A large square poured concrete foundation was uncovered in this area (Figures 6.1 and 6.5). The north and south walls of the foundation measure approximately 10.5 feet while the east and west walls measure approximately 10 feet. The foundation wall itself is 1.5 feet wide. A few bases of bricks remained on the surface of the south foundation wall. The bricks were of a cream or tan color and were machine made. Each brick measured six by two inches and were laid in what appeared to be a stack bond pattern, although this may be deceiving as few bases were present. The interior of the feature appeared to be a rubble-filled shaft. The 1945 NPPC inventory described the elevator as “an old Otis elevator and shaft, three stories height, enclosed in steel and stucco.”

Subsequently, Machine Trenches 5 and 6 were excavated adjacent to the elevator shaft feature in an attempt to locate the rear foundation or foundation wall of the row house (Figure 6.1). Machine Trench 6 was quickly terminated. This small trench was excavated into a zone of brick rubble at which point the machine operator indicated that excavations should be terminated in this vicinity due to the proximity of underground utilities. Machine Trench 5 was excavated at the southwest corner of the elevator shaft in a southeast to northwest direction. It was approximately 7.5 feet long and 2.25 feet wide. Both machine trenches encountered a fill of dense brick rubble and other structural debris to the base of excavations. Machine Trench 6 was excavated to no more than 30 cm below the scraped surface, while Machine Trench 5 was excavated to about 50 cm below the scraped surface. As well, the extension to the rear of the bay as depicted on the 1903-1916 Sanborn map was not located.

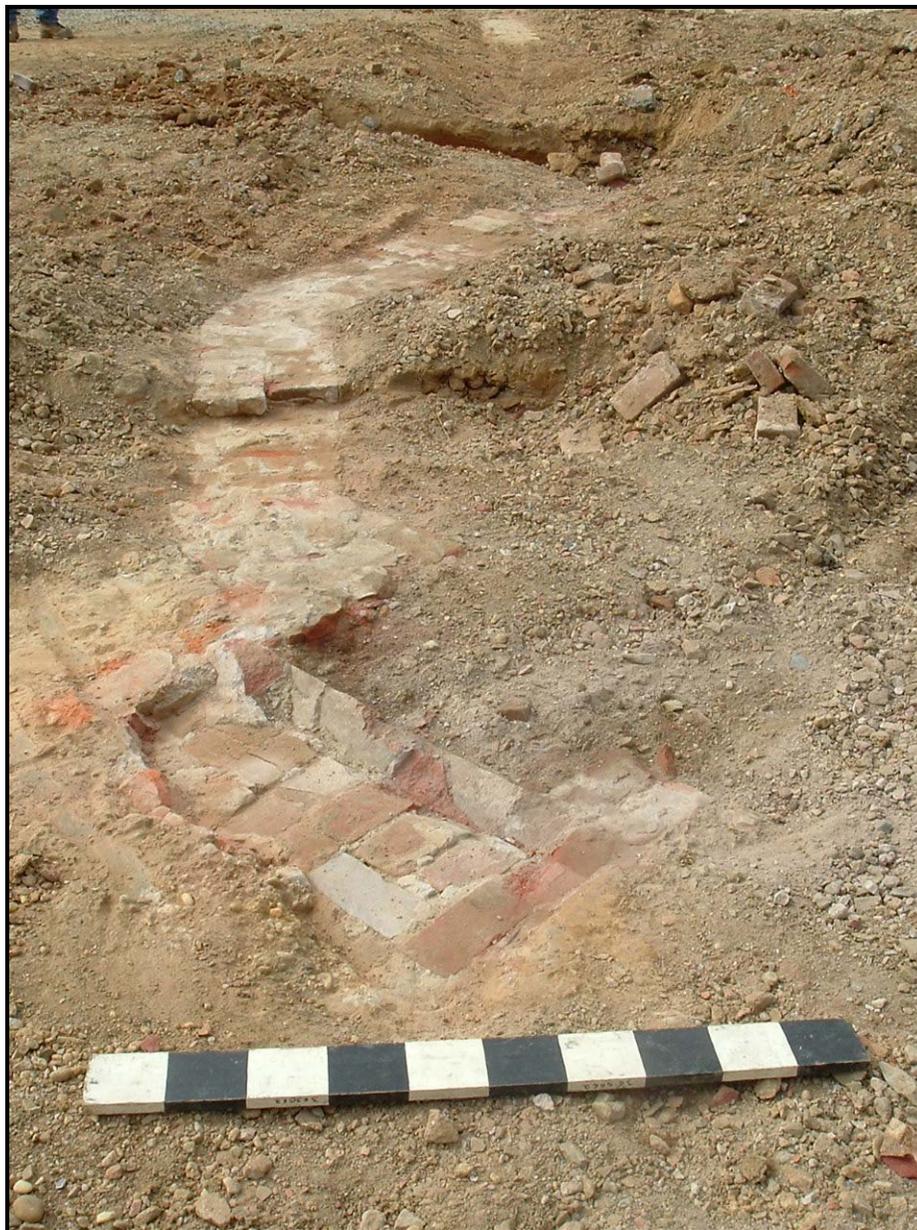
**Figure 6.6: Bay feature**

The archival and historic map research (Section 4) indicated that three structural features could be found along the row house east wall. These include the original foundation wall, the post-1888 bay, and features associated with the post-1888 porch addition. As the removal of the upper deposits continued to the south, a structural feature was encountered along the east boundary of the area of interest. This feature consisted of a brick masonry foundation wall with an angular shape that resembles the bay depicted on the 1903-1916 Sanborn map and the 1945 structure plat (Figures 6.1 and 6.6). The foundation wall was two bricks wide, with each brick being set lengthwise. Each brick was approximately 8 inches long, and the wall just over 16 inches in width. Each brick was approximately 4 inches wide. In most areas, the brick masonry foundation wall appears to have been laid in a stack bond pattern, although deviations from this pattern are present.

The feature itself can be divided into three parts—south, central, and north. The south part is angled to the southwest in a manner similar to the 1945 plat and approximately 5.25 feet of the wall was uncovered. The central part of the bay is oriented north-south and is similar to that depicted on the 1945 plat. The central part of the bay measures approximately 5.5 feet in length. The north end of the bay deviated from the shape as depicted in the 1945 structure plat. The plan indicates that the wall should mirror the angle on the south part of the wall but oriented to the northwest. Instead, a J-shaped feature extended to the east of the bay. Portions of the northwest and southeast walls of this feature had a width similar to that of the south and central bay walls, approximately 16 inches. However, the middle of the feature had a greater width. It is approximately 15 inches wide with the bricks set both length and widthwise. The last row of bricks (innermost or westernmost) was set at an angle to form a bevel.

The bay appears to be an addition made by Hurt in 1888. According to the 1888 D.C. building permit (Appendix C), Hurt added a side porch and installed bay windows that year. While, the 1888 Sanborn map does not depict this feature on the 1625 P Street, the 1903-1916 Sanborn map does indicate that the bay was present. The “J”-shaped feature may be associated with the reconfiguration of the house’s chimney that occurred during a renovation in 1895.

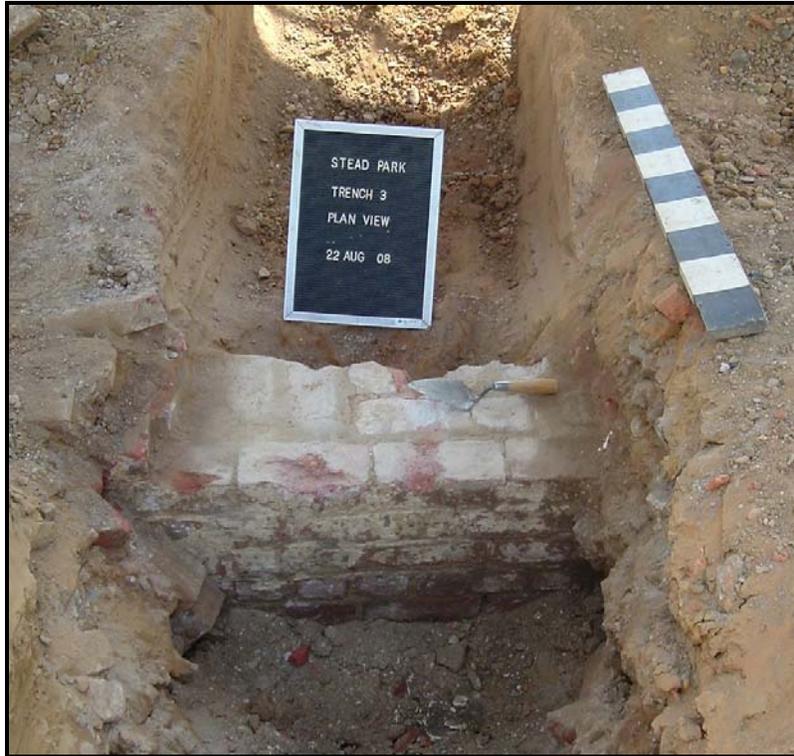
Figure 6.7: Foundation wall exposed in Machine Trench 3

However, the foundation wall could not be located during the removal of the upper deposits between the wall segment located at the southeast corner of the structure and the bay. It was decided to excavate trenches in an east-west orientation in this area so as to intersect the wall or foundation. Machine Trenches 2 and 3 were excavated between the two visible features (Figure 6.1). The northernmost, Machine Trench 3, was located approximately 1.5 feet south of the bay. It extended from east of the bay into the center of the row house. This trench measured approximately 10.3 feet east-west and was 3 feet wide. At approximately 3 feet to the west of the east trench wall the brick masonry foundation wall was encountered (Figure 6.7). Visually, this segment of the wall was in line with that exposed on the surface to the south, but is situated to the west of the bay. The exposed segment was found between 30 cm and 35 cm below the previously excavated ground surface. Five courses of bricks remained over a concrete foundation. It can also be noted that the trench profile to the exterior of the foundation wall consisted of strong brown (7.5YR5/6) clay devoid of structural debris or other artifacts. The profile to the interior of the foundation wall consisted of structural debris.

The excavation of Machine Trenches 2 and 3 demonstrates that the east wall of the 1625 P Street, NW row house remains intact under structural debris. The same brick pattern as that noted for the southeast corner foundation wall is repeated on the wall segments uncovered in Machine Trenches 2 and 3. It is likely, however, that more of the foundation wall was demolished between the southeast corner remnant and the bay, than was demolished in either of those areas. This would account for the fact that the foundation wall was encountered at deeper depths below ground surface. Differential demolition was noted in these two trenches as well, as five courses of brick remained in Machine Trench 3 but only one course remained in Machine Trench 2.

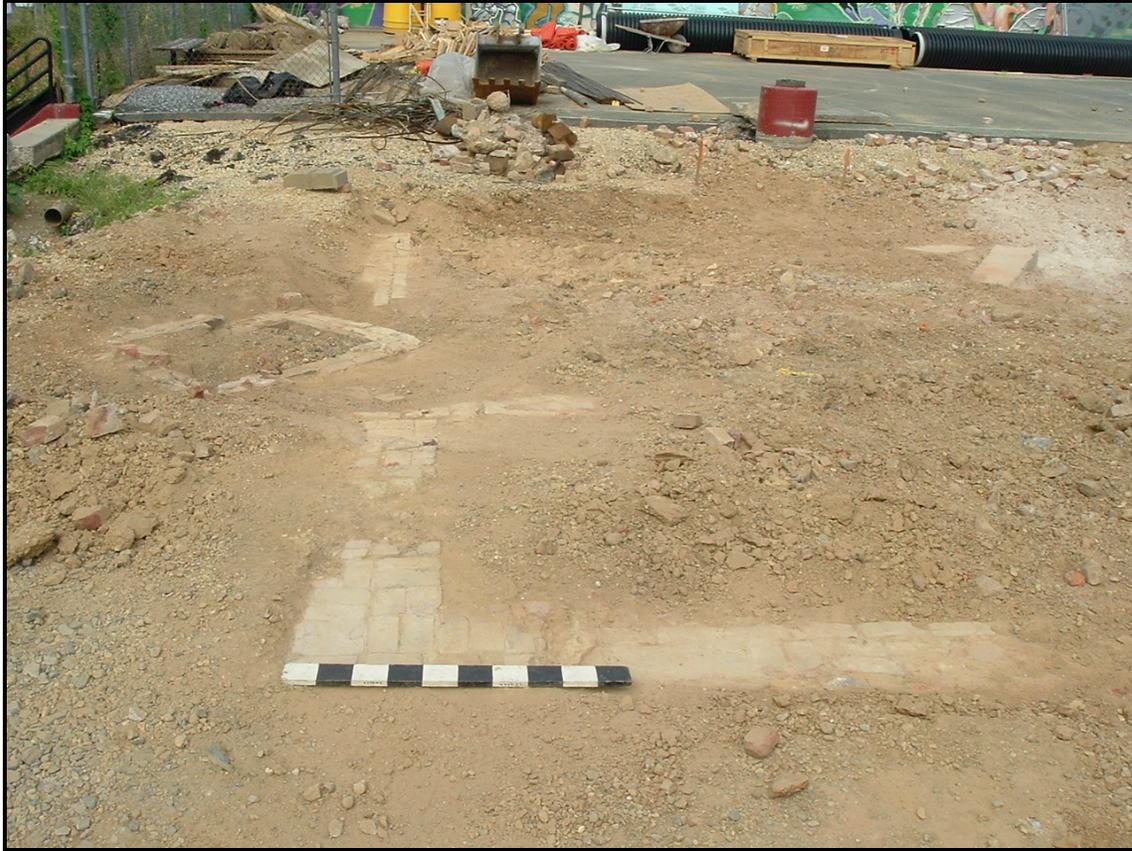
**Figure 6.9: South wall features**

Both the archival and map research (Section 4) and the DC HPO trench excavation indicated that the south foundation wall would be present in the southern portion of the area of interest. Historic maps indicate that the southeast corner of the structure also was the location of the main entrance to the Hurt row house. Finally, excavations in this area were designed to investigate a feature found midway along the south wall during the DC HPO investigations of the site area. With the completion of Machine Trenches 2 and 3 along the row house east wall, the removal of surface deposits along the south boundary of the area of interest was continued and completed. The southeast corner wall segments were first exposed (Figures 6.1 and 6.9). This wall feature had been almost completely uncovered by the DC HPO trench excavation. As discussed earlier, the current excavations were able to extend the east wall of the southeast corner northward. The DC HPO excavations had completely uncovered the south-facing wall within this segment, while the current excavations were able to expose an additional small segment of the western portion of this feature to the north. When completely exposed, this somewhat U-shaped feature had a south wall that continued 7.5 feet west of the southeast corner, at which point a wall segment extended 2 feet to the north.

Approximately 8 feet to the west of the southeast corner foundation wall was an isolated segment of the south-facing foundation wall that had also been uncovered by the DC HPO trench excavations (Figures 6.1 and 6.9). Approximately 7.25 feet of this segment had been exposed. The removal of the upper surface deposits in all directions from this isolated segment did not reveal any foundation wall extensions. The nature of construction of this foundation wall segment appeared to be similar to that described for the southeast corner segment as well as the foundation wall segments present in Machine Trenches 2 and 3. The westernmost end of the segment appeared to be a finished corner, while the easternmost end had a jagged appearance, suggesting that a portion of the wall between this southwestern segment and that of the southeast corner segment had been demolished. A similar jagged appearance, however, was not present on the westernmost end of the southeast corner foundation wall segment.

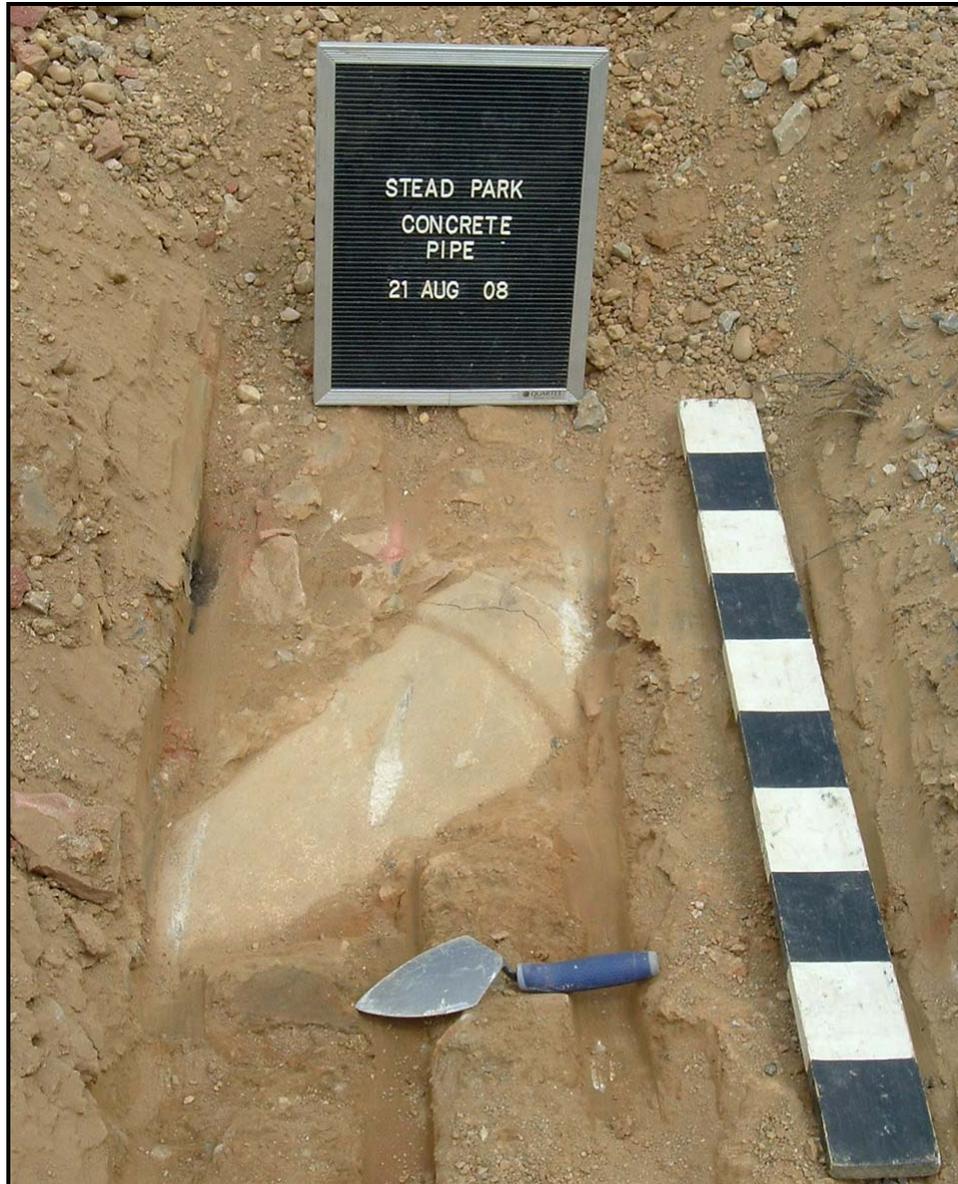
**Figure 6.10: Concrete storm water pipe.**

Upon the exposure of this off-angle feature, several individuals from DC HPO and DPR noted that the rectangular feature was in line with an exposed concrete pipe and storm sewer manhole to the east. It was decided to excavate a trench (Machine Trench 8) adjacent to the east corner to determine whether this concrete pipe was connected with the rectangular feature (Figure 6.1). The concrete pipe was indeed located just under the scraped ground surface (Figure 6.10). The rectangular feature appears to be a storm water management feature. This would suggest that the feature was constructed after demolition of the 1625 P Street, NW row house. The off-angle placement of this feature also suggests a post-demolition period of installation.

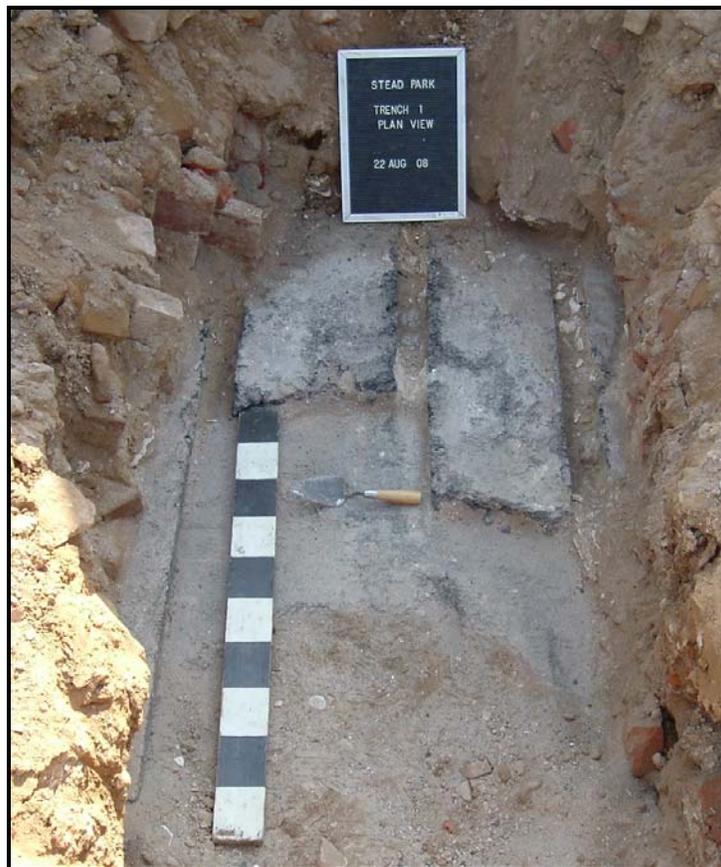
**Figure 6.11: Machine Trench 1 and the grooved asphalt surface.**

Machine Trenches 1 and 4 were excavated in an attempt to locate what was expected to be a deeply buried foundation or foundation wall along the west side of the row house (Figure 6.1). The excavation of Machine Trenches 2 and 3 near the center of the east wall of the row house had indicated that wall foundation segments could be buried beneath between 30 cm to 50 cm of rubble below the scraped surface. Machine Trench 1 was placed approximately 6.75 feet north of the southwest foundation wall segment. It was oriented east-west, measuring 6.25 feet long by 3 feet wide, in an attempt to intersect the west wall. The subsequent results of the Machine Trench 4 excavation indicated that Machine Trench 1 was located too far to the east to intersect the west wall. The initial 50 to 60 cm below the scraped surface in Machine Trench 1 consisted of dense brick rubble intermixed with loose soil. At the base of excavation, a grooved asphalt layer was encountered (Figures 6.11 and 6.12). The asphalt layer consisted of raised areas divided by grooves. Three grooves were exposed in Machine Trench 1, with each groove being 3 inches wide. The raised areas between the grooves were 14 inches and 9.5 inches wide, respectively. It appears that additional raised areas extended to the north and south of Machine Trench 1, and this entire feature extended outward in all directions from this excavation unit. The grooves and raised areas were oriented east-west. The toothed bucket had removed the asphalt floor along the west end of Machine Trench 1. Examination of the profile below the intact asphalt floor revealed the presence of a layer of seemingly intact bricks, perhaps representing an earlier intact floor. The bricks rested upon strong brown (7.5YR5/6) clay subsoil.

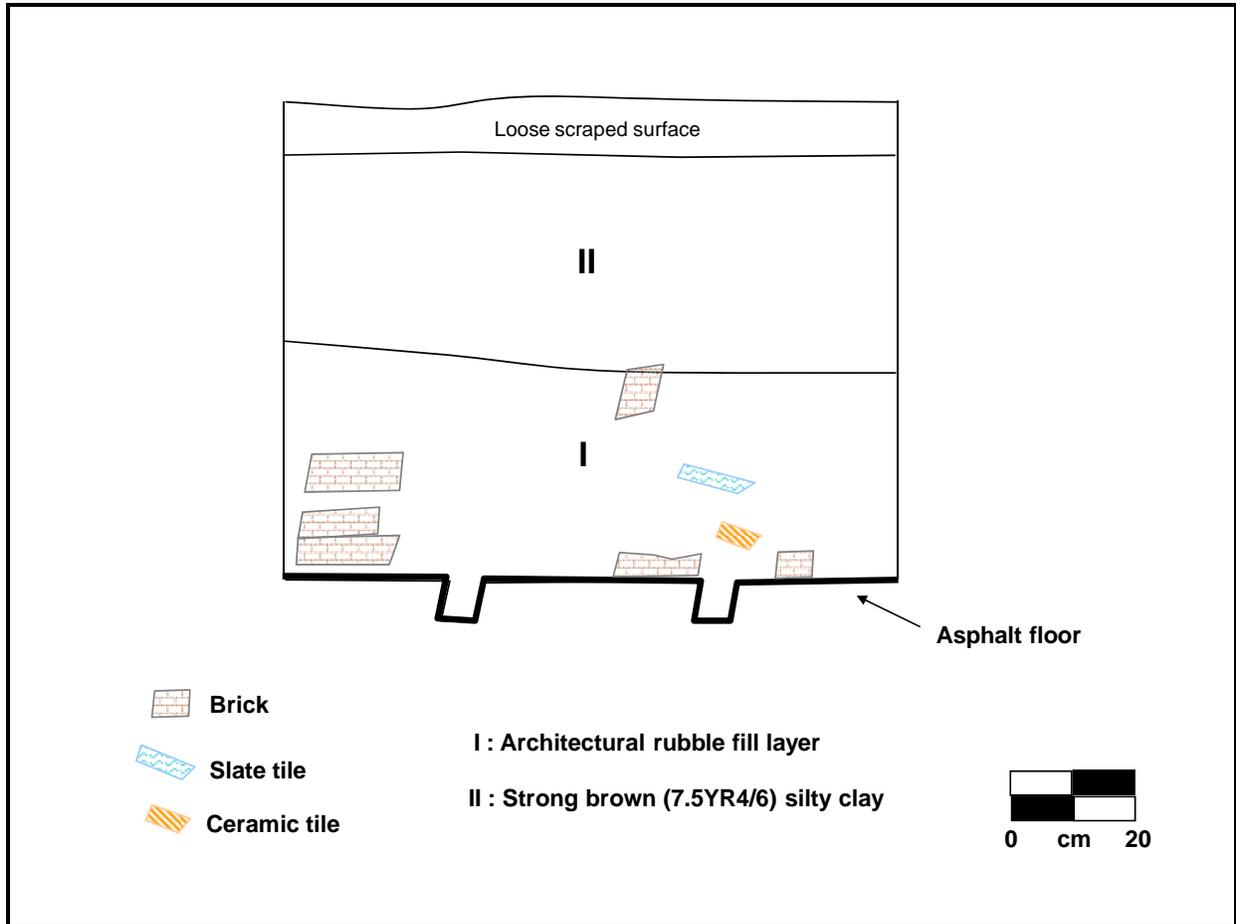
**Figure 6.13: Test Unit 1 west wall profile.**

Test Unit 1 was then excavated to the north of Machine Trench 1, also in an attempt to locate the west wall of the row house and to investigate a dense deposit of disintegrated plaster (Figure 6.1). This one by one meter test unit was placed 5.5 feet north of Machine Trench 1. The excavations continued to 75 cm below ground surface and three deposits were identified (Figure 6.13). The initial deposit was 10 cm thick and coincided with the deposit of very loose degraded plaster. The second deposit was thickest along the west test unit wall and became thinner to the east. At maximum, this deposit of strong brown (7.5YR5/6) silty clay was 35 cm thick. Few artifacts or structural materials were associated with this second deposit. Immediately below the second deposit, and continuing to the base of excavations, was a dense layer of architectural debris, including bricks, tile, mortar, and degraded plaster, among others. Once again, this layer of structural debris was situated above an asphalt floor, similar to that described for Machine Trench 1 (Figures 6.13 and 6.14). Like the Machine Trench 1 floor, the grooves were oriented east-west, and were 3 inches wide. The one completely exposed raised area was approximately 14 inches wide, similar in width to one of the raised areas in Machine Trench 1.

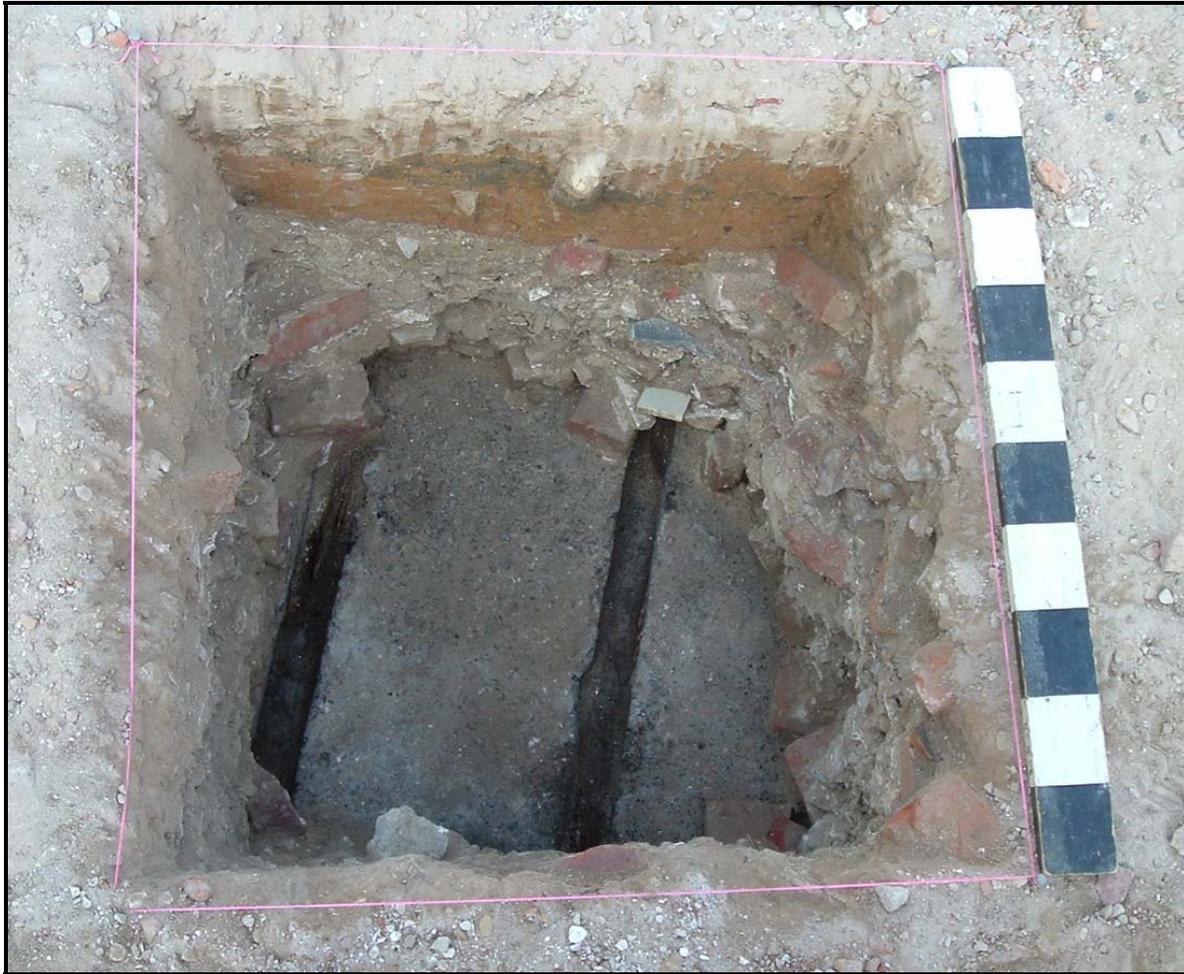
**Figure 6.14: Grooved asphalt floor in Test Unit 1**

Consultation with architectural historians at DC HPO and EHT Tracerics, Inc. indicated that the most likely function of the grooved asphalt floor was that of a sleeper system. Sleepers are strips of wood placed over a concrete (or in this case, asphalt) floor onto which the flooring may be laid and nailed or glued (Phillips 1994:155). The sleepers may have been laid into the grooves to provide additional stability to the floor. The remains of wood strips were found in the Test Unit 1 grooves, including one piece that had a number of embedded machine-cut nails. Such nails were commonly used through the 1890s, after which wire-drawn nails became increasingly common. This suggests that the asphalt floor and sleeper system may have been installed after 1888 or during the 1895 renovation of the row house.

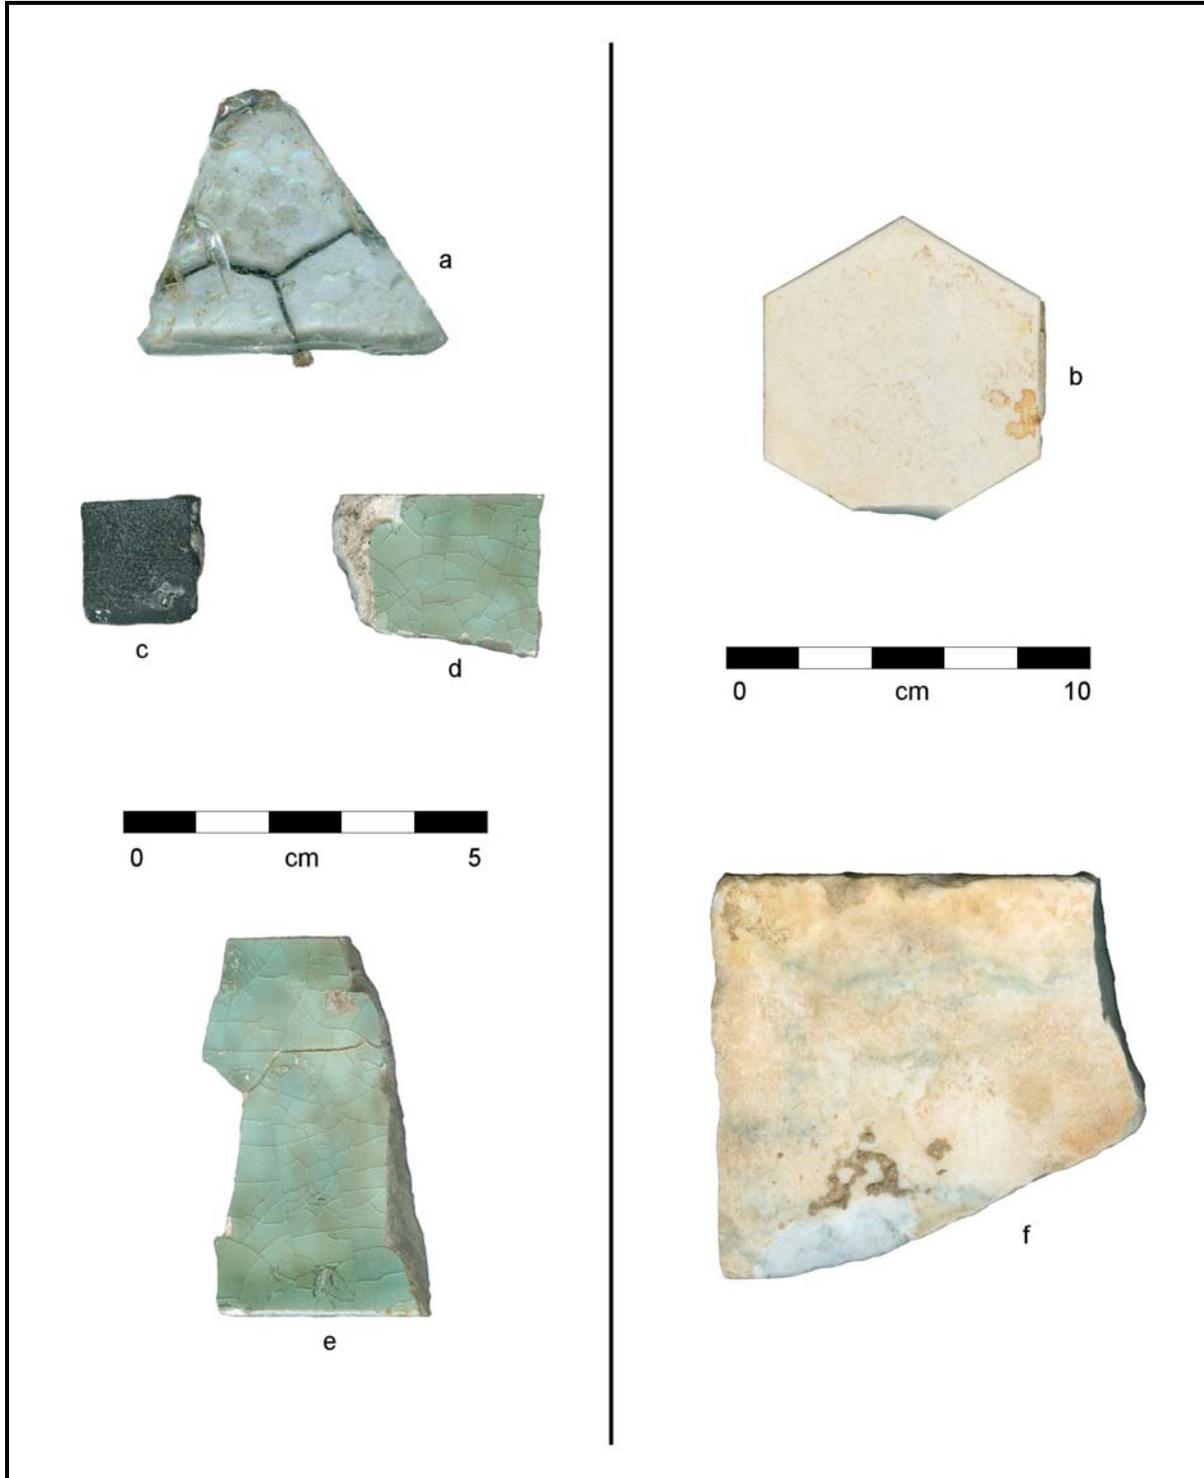
Figure 7.1: Selected artifacts from Stead Park: a, safety glass; b-e, tile fragments; f, marble slab.

A total of 13 pieces of mortar were collected, representing nearly 7 percent of the Architecture group. Mortar fragments were collected from Test Unit 1 and during monitoring of the removal of the upper surface deposits. Like the ceramic tile, mortar was observed during the monitoring of the machine trenches but was not collected due to its ubiquitous nature. One large conglomerate architectural piece was recovered consisting of concrete with gravel aggregate, mortar, and two green ceramic tiles. This piece was recovered from Test Unit 1.
