# Hurt House at Stead Park

Phase I/II Archaeological Investigation

District of Columbia Site 51NW223

DRAFT – October 2008

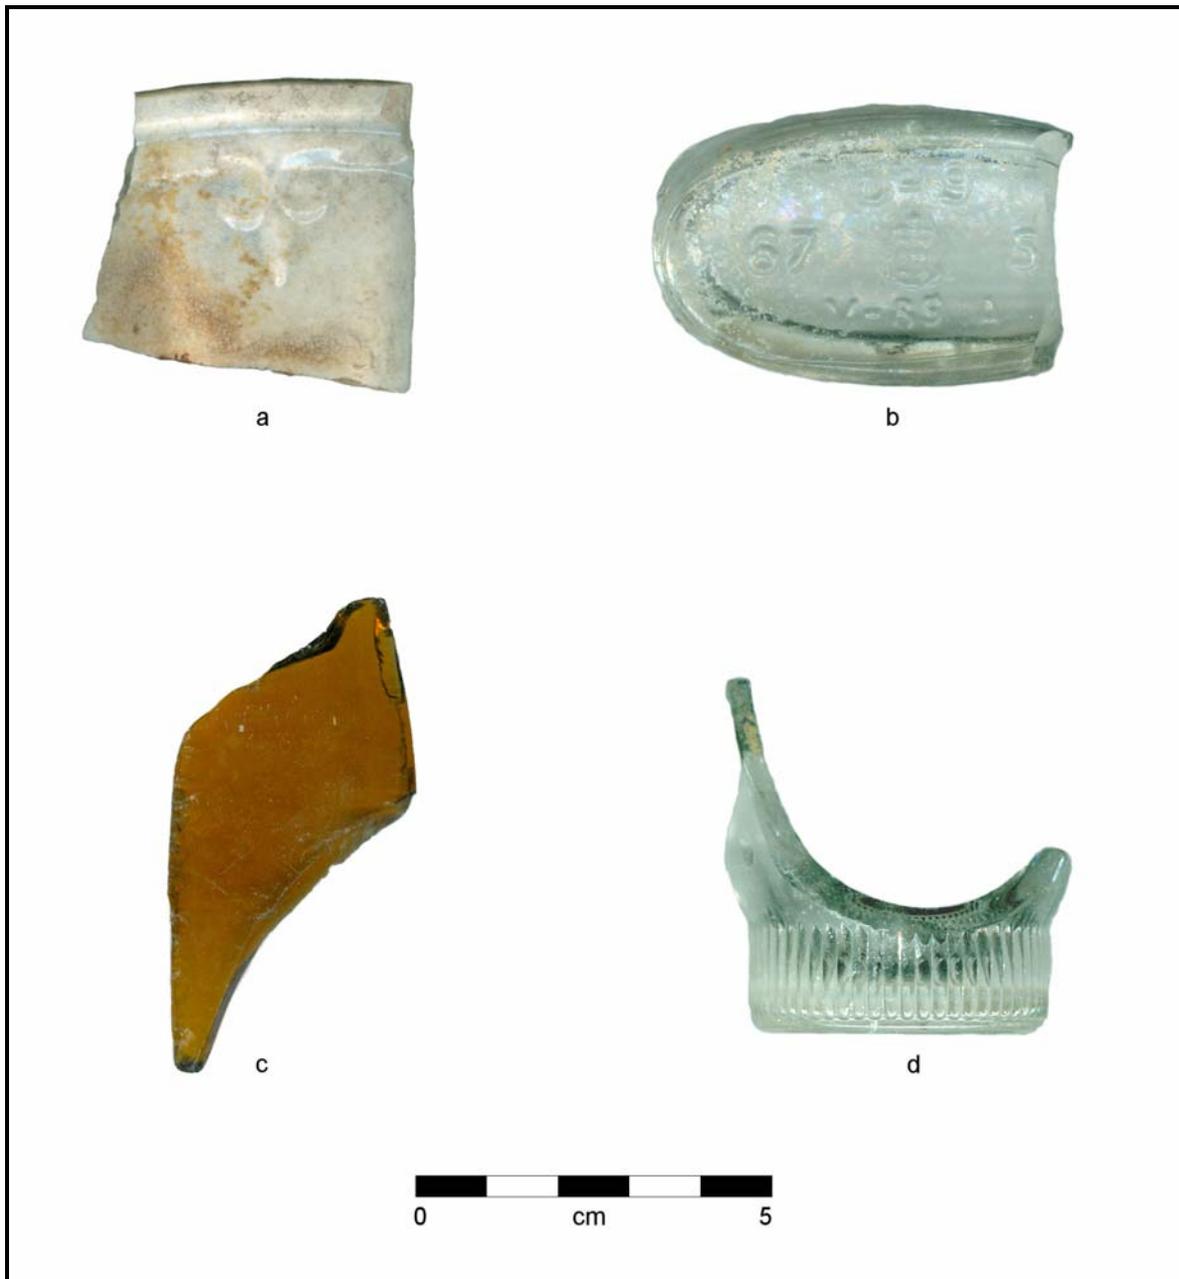
**Figure 7.2: Selected artifacts from Stead Park: a, ironstone rim with fleur-de-lis decoration; b, Anchor Hocking bottle base; c, brown bottle body; d, tumbler base.**

all undecorated, are too small to identify vessel form. However, it is likely that three of these rims represent either plates or bowls. Two of the ironstone sherds are mold-decorated and include scalloped-edge rim and a fleur-de-lis decorations (Figure 7.2, a). The scalloped-edge rim is thin, suggesting that it is from either a small bowl or saucer. The fleur-de-lis decorated rim has an almost vertical profile, perhaps indicating that it is from a jar or serving vessel. Both undecorated and mold-decorated ironstone typically dates from ca. 1840 to 1900 (Mansberger 1988), with mold-decorated ironstone production continuing at least through 1910.

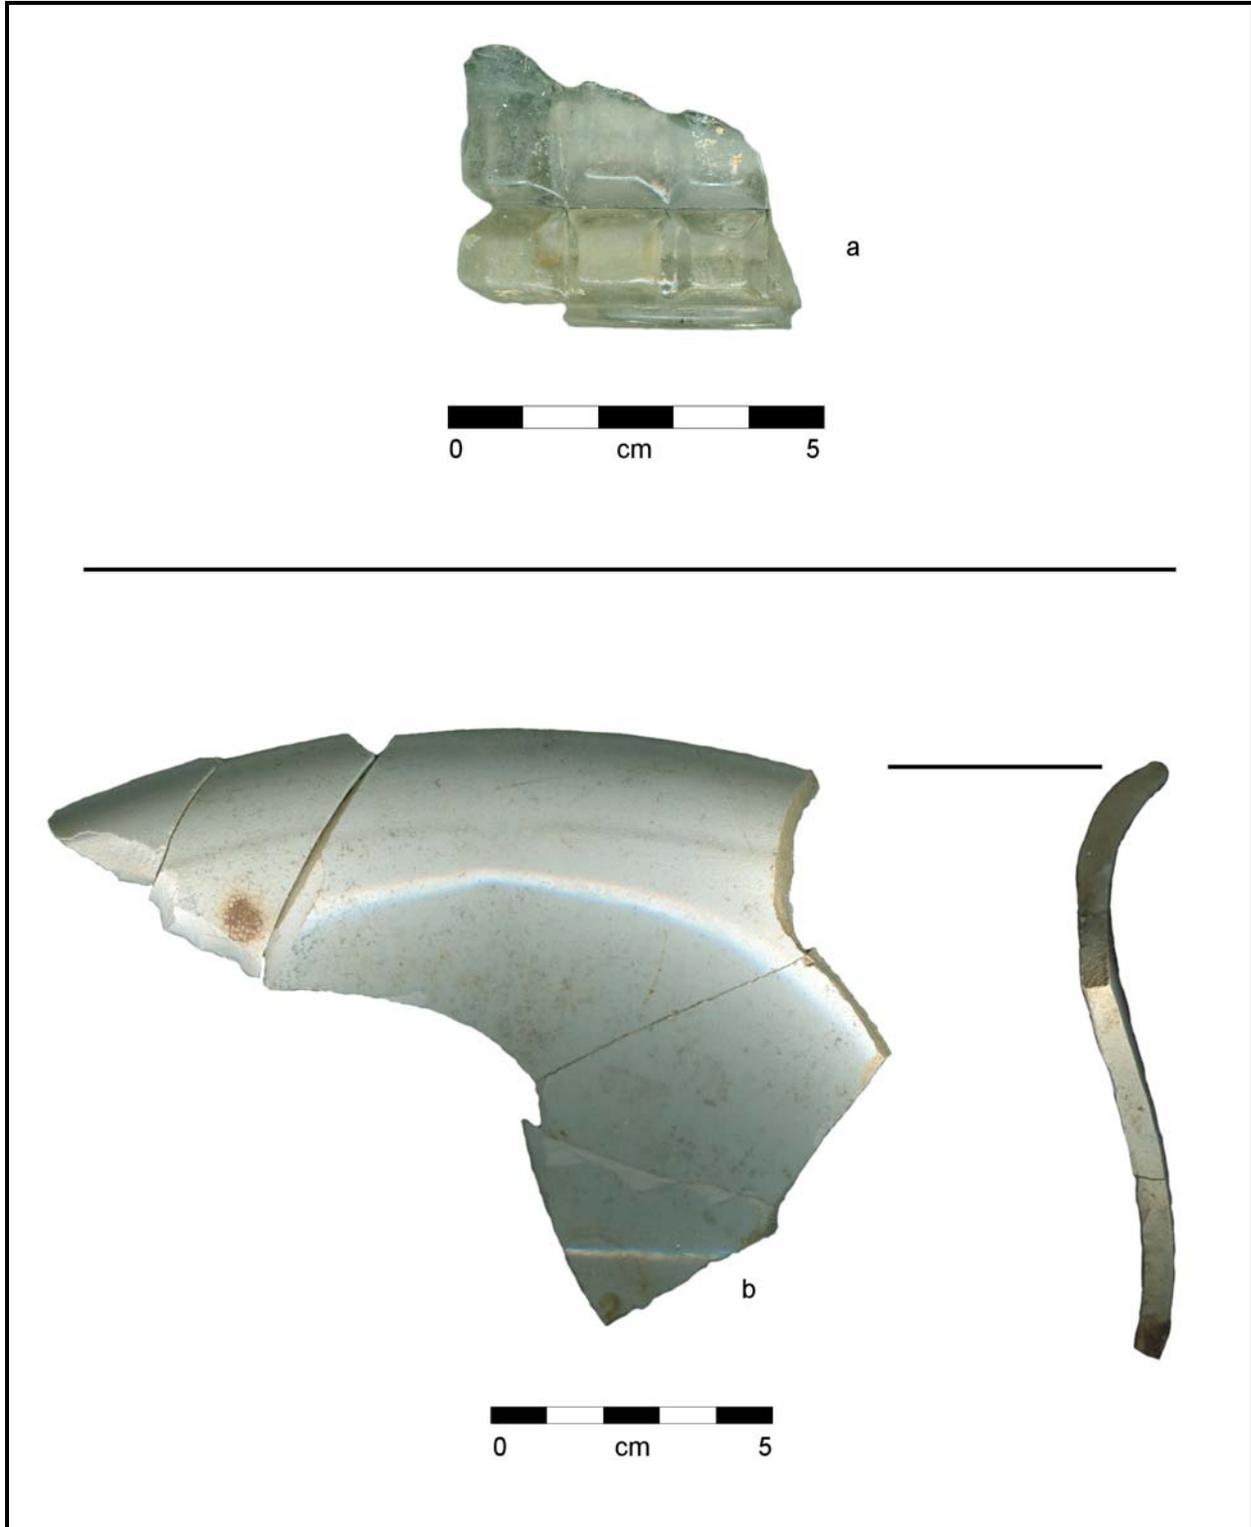
**Figure 7.3. Selected artifacts from 51NW223: a, ink well; b, chamber pot.**

The Activities group is composed of four artifacts, which represents 1.5 percent of the total historic artifact assemblage. Artifacts assigned to this group include two fragments of a plastic toy part, a plastic token/chip, and a fragment of a glass ink well (Tables 12.3 and 12.4). The plastic token/chip is clear in color and was found in Test Unit 1. Also found in the test unit is a black toy car wheel with the company name "STROMBECKER" printed on the tire. The Strombecker Company dates to 1876, at that time using the name National Laundry Journal and manufacturing buttons and cufflinks. The Strombecker name was first used in 1961 and is still used today. In the early part of the 1960's, Strombecker was one of the industry's leaders in toy car-and-track set manufacturing (Uhle, Answers.com). The ink well was found during the monitoring of the removal of the upper surface deposits. It has a cube-shaped form and was made of clear glass (Figure 7.3, a). It was machine-made with a pressed glass "cut glass" design. Being machine-made, this ink well post-dates 1903.
